# Manhole Inspection Summary

Manhole # S15II1021MH

Insp Date: **6/15/07 1:53 PM**

**Location** Address: **GREENSPRING AVE**

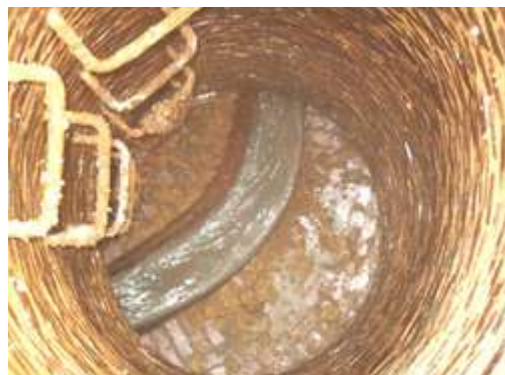
Top View

Corroded steps. Evidence of surcharge - Bench debris.

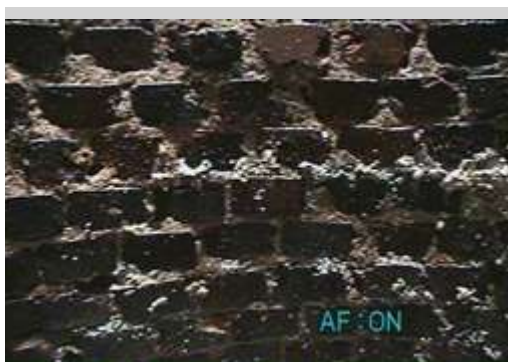
Defect

Barrel infiltration.

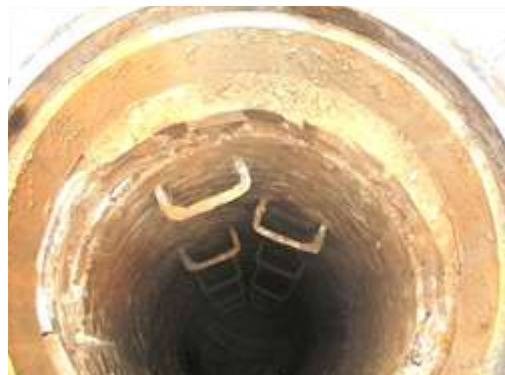
Defect

Frame leaks. Frame offset. Adjustment deterioration and infiltration. Barrel infiltration.

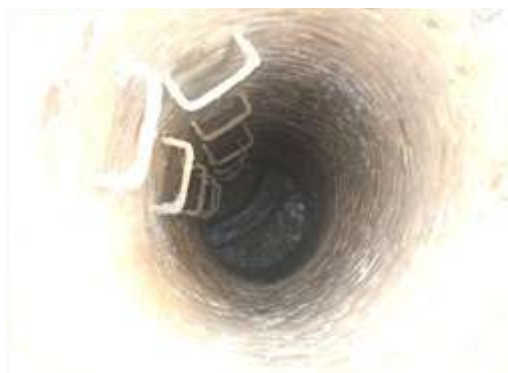
Defect

Adjustment and Barrel infiltration.

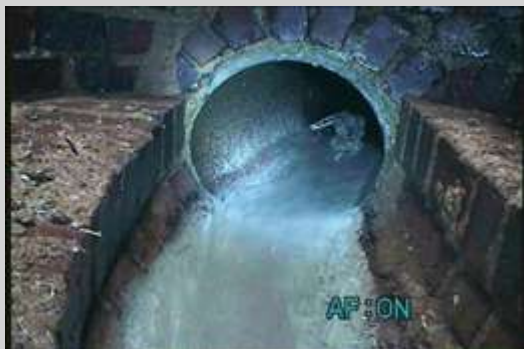
### 12 in. Circular Gravity Sewer Pipe In @ 8 O'Clock

Deposits: ☐ None ☐ Mud ☐ Sludge ☐ Debris ☒ Grease

Silt Depth: **0** (in.) Deposits Extent: **Light**
